Prepared by Heritage Studies, Inc. Princeton, N.J. 08540 609-452-1754

NEW JERSEY TRANSIT RAILROAD STATION SURVEY

- A. Name: Common Tuckahoe *Station* Historic Line: Seashore Line (Atlantic Coast RR)
- B. Address or location: ~~W. Side of Railroad Ave.~~ Tuckahoe, N.J. 08250 County: Cape May Municipality: Upper Township Block & lot a part of 594.01/3
- C. Owner's name: NJ Transit Address: Newark, N.J.
- D. Location of legal description: Office of the County Clerk, Cape May Co. CH, Cape May, NJ
- E. Representation in existing surveys: (give number, category, etc., as appropriate)

FACILITY NAME: Tuckahoe

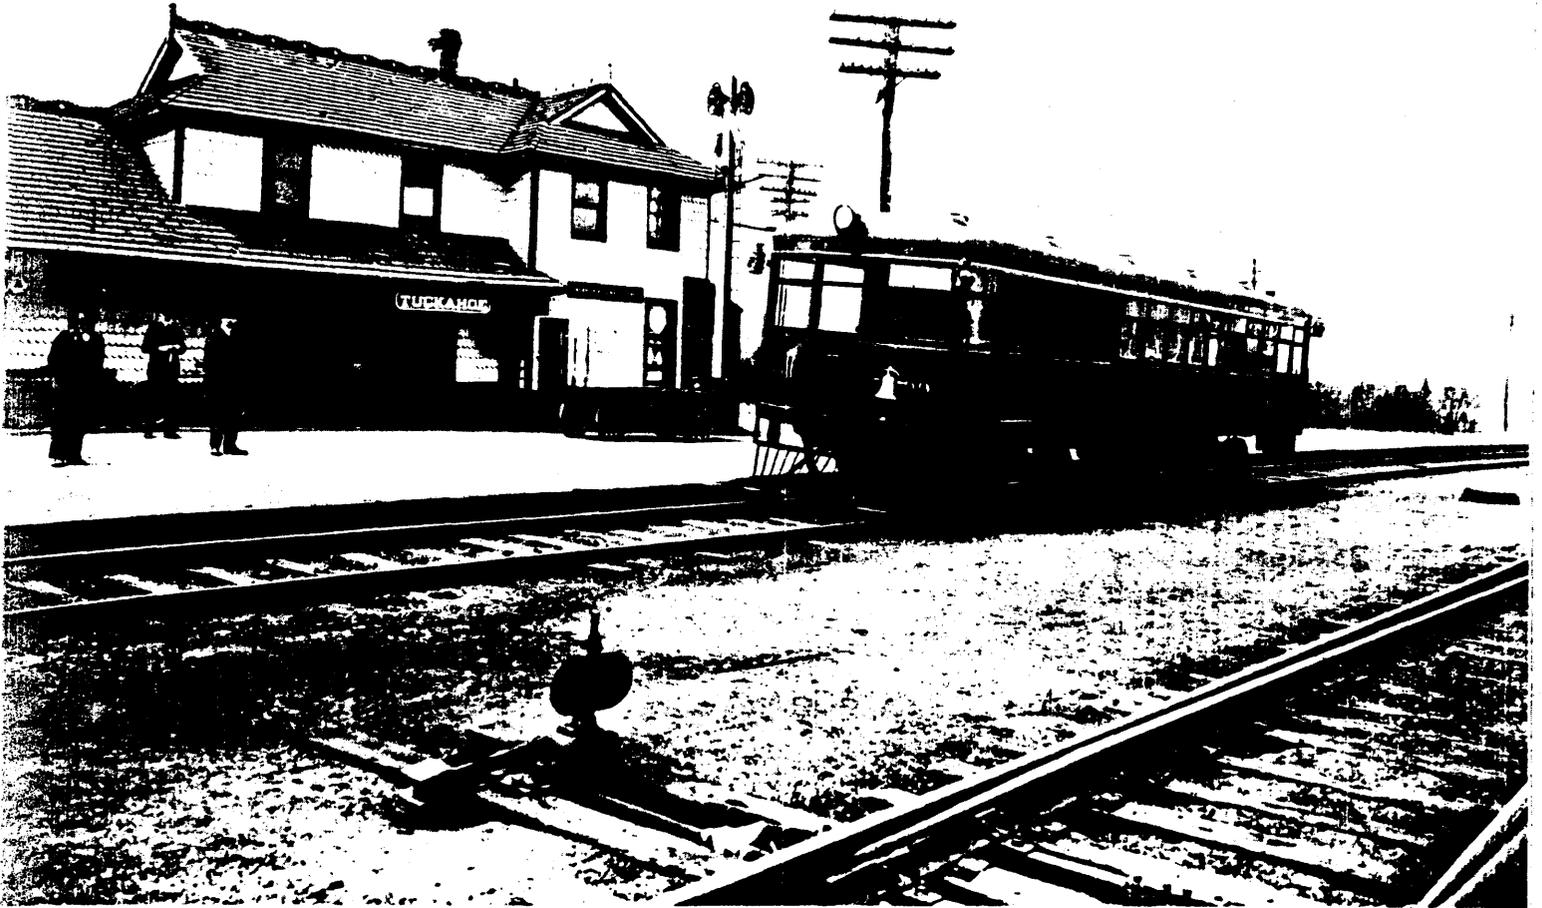
11-3 Tuckahoe Railroad Station (Cook and Coxe, p. 137)

(Above) Declining traffic volume combined with the poor condition of the Sea Isle City branch resulted in the substitution of this small gas-mechanical car for steam train service. This April 4, 1923, view of Tuckahoe station shows the newly acquired car, which was one of several on the ACRR at this time.

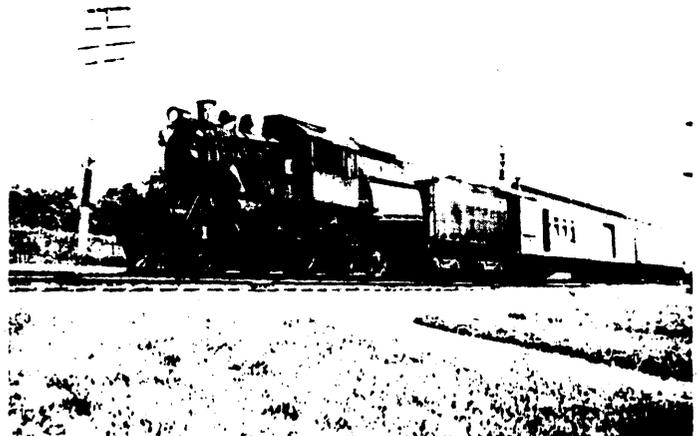
11-3 Tuckahoe Railroad Station (Cook and Coxe, p. 136)

(Below) In this morning scene at Tuckahoe, the local to Cape May has a typical consist of a coach and a sixty-foot steel combination baggage and Railway Post Office car.

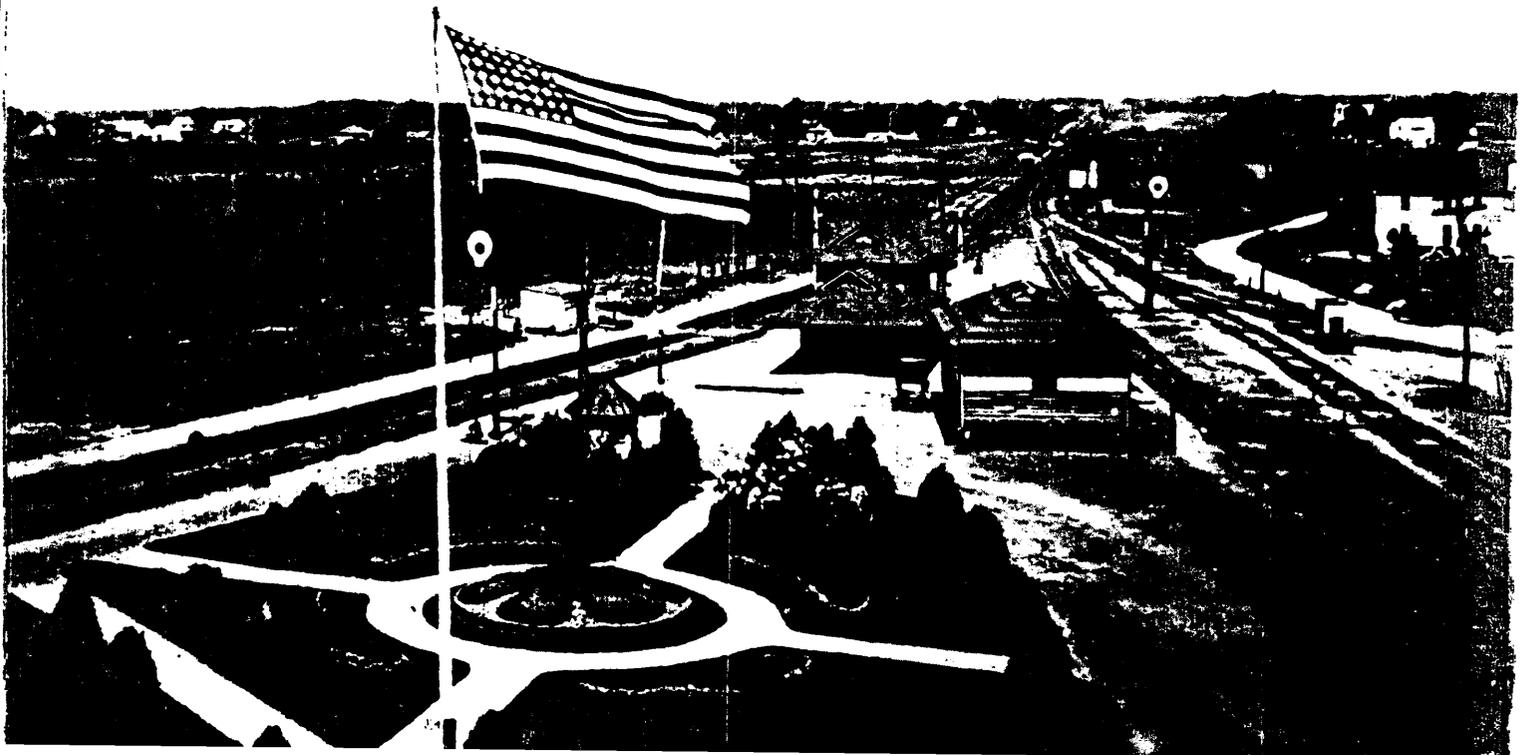
11-3 Tuckahoe Railroad Station (Cook and Coxey, p. 86)

The ACRR employed several gardeners during the summer to tend the many gardens located at most of the larger stations. This 1922 scene of Tuckahoe shows one of the largest and finest track-side displays. This photograph was taken from the new steel water tank, which replaced two smaller wooden tanks. Note the typical Reading octagonal outhouse in the shrubs near the station. The track scale on the right was used to weigh the many carloads of sand shipped to the island resorts for fill.

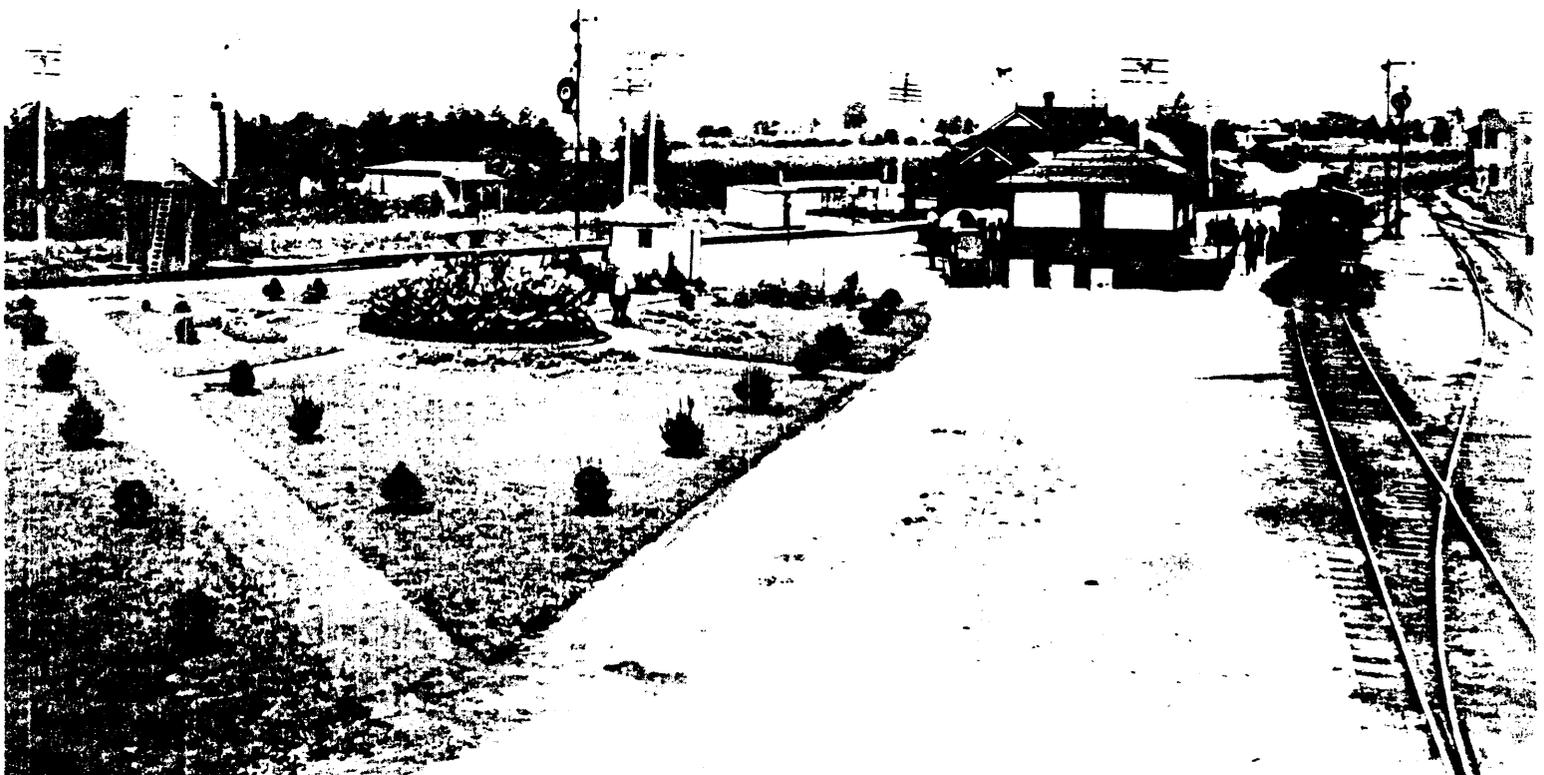
The Ocean City branch water tank provided the Company photographer with an excellent vantage point overlooking Tuckahoe. Note the beautiful grounds in this August, 1911, scene with the ACRR gardener standing in the middle of the well-tended garden. The two-car train headed by No. 8 may have been the photographer's special train.
